Stag Carburettor Conversion

Strombergs v SU's

Brian Tink, TCC ACT

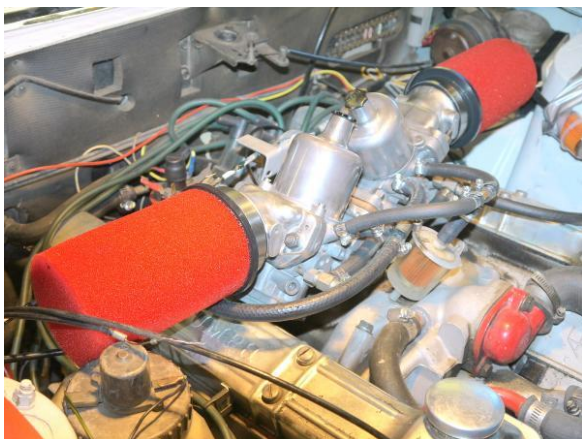
Third problem: the carbies and the rocker covers have a contact problem. To overcome this it was necessary to raise the carbies about a centimetre with the use of a spacer, which created problem number four.

Fourth problem: the retaining bolt holding the plinth is too short. No problem, a piece of steel rod, a couple of dies and presto, a new bolt.
