Stag Head Gasket Issues

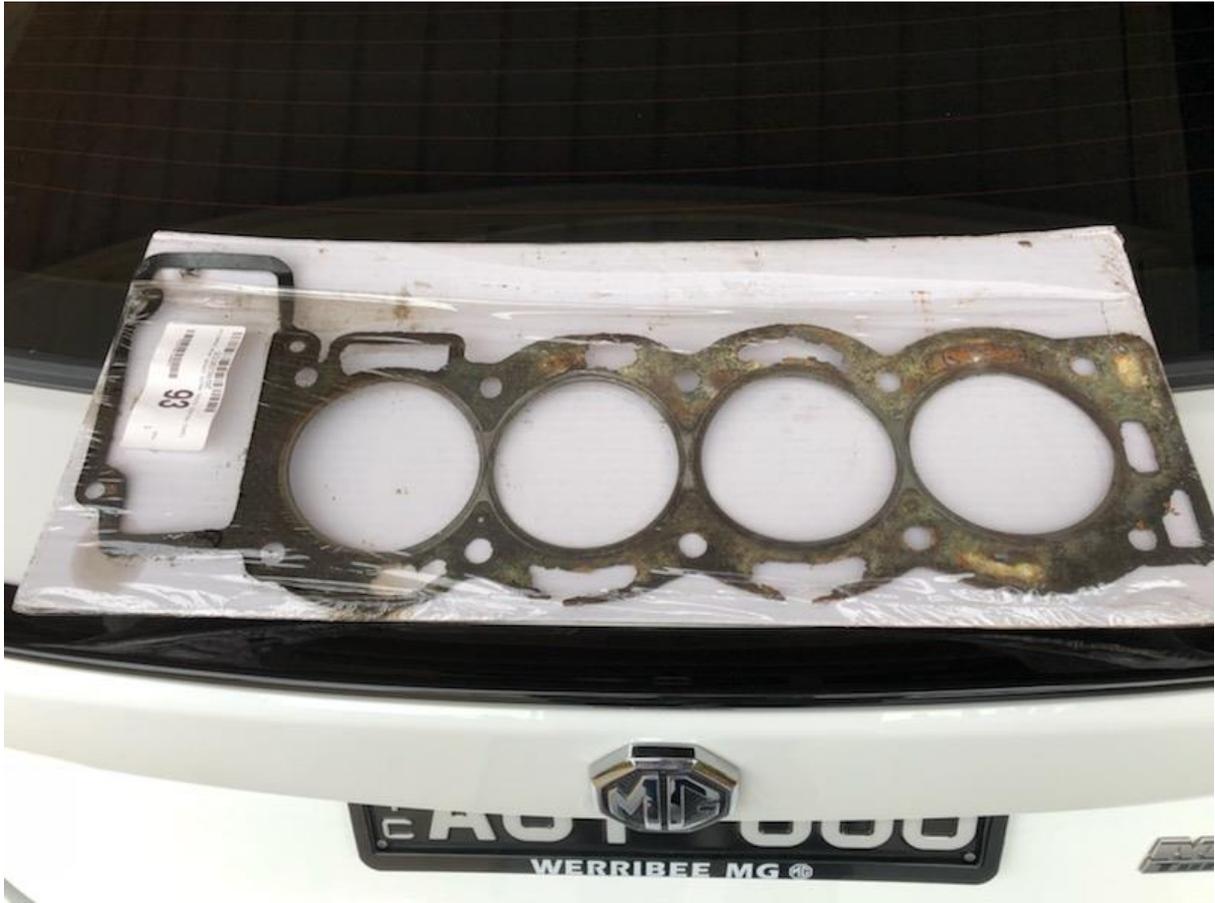
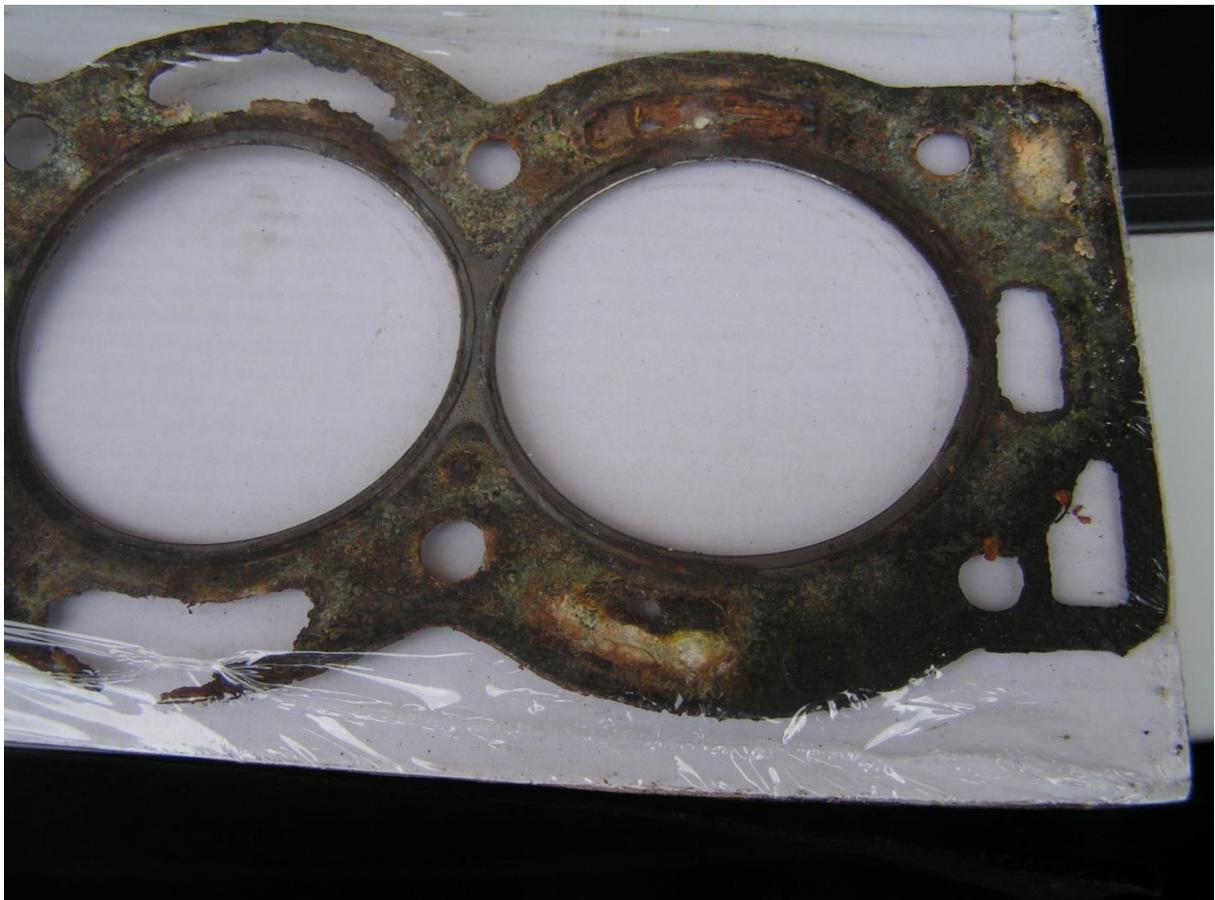
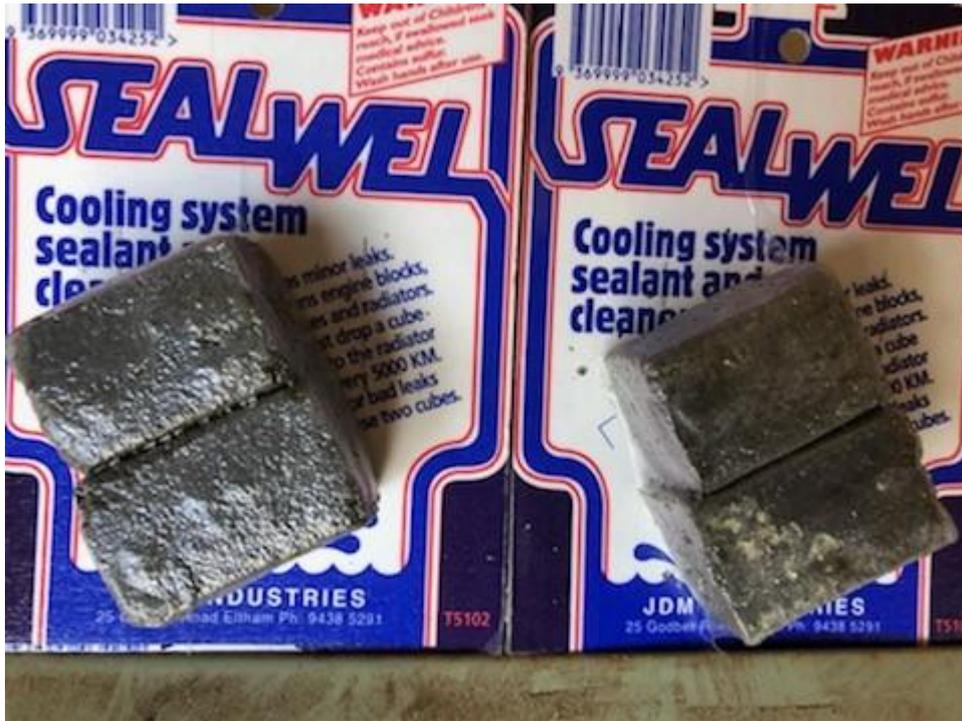
John Smith gave me a ride to Paynesville in his black Stag to pick the car up and it still runs beautifully. Thanks John. Last Club meeting I took the head gasket along and passed it around the Members. The last cylinder on both sides of the water galleries were blocked from a build of a whitish substance. Refer to the attached photos. This could stem from the fact that the Stag block is cast iron and the heads are aluminium. Brad put Penrite Coolant with a life of 7 years in the radiator. Greg Tunstall in QLD recommends that coolant be replaced every year to help illuminate the build up inside the Stag engine. Terry Roche and Dale Ross recommends a product called SEALWELL. This product cleans the internals of the block and heads and helps prevent leaks. One cube goes into the radiator every 5000 kms. I bought the SEALWELL product from Bursons for \$12.50. This is good for 10,000 kms. Don't forget to ask for your Triumph discount. Google this product. I can highly recommend the EWP and John Benson from Davies Craig will give TCCV Members a very good discount (0418 130 600). Davies Craig advertise in the Trumpet.

Brad Ash who built this car and runs a Garage in Paynesville (0403 356 622), was given the task of replacing the Head Gaskets. Brad now gets to service all the local Triumph cars. Brad used to own British Auto Care in Brisbane. He did his Apprenticeship there when he was much younger. He now has a white GT6 which was his mother's car. We bought his magenta Stag 10 years ago.
